REPORT OF INVESTIGATION

Fatal Powered Haulage Accident  
February 10, 2004

Cucumber Mine  
Raw Coal Mining Company, Inc.  
Cucumber, McDowell County, West Virginia  
ID No. 46-08580

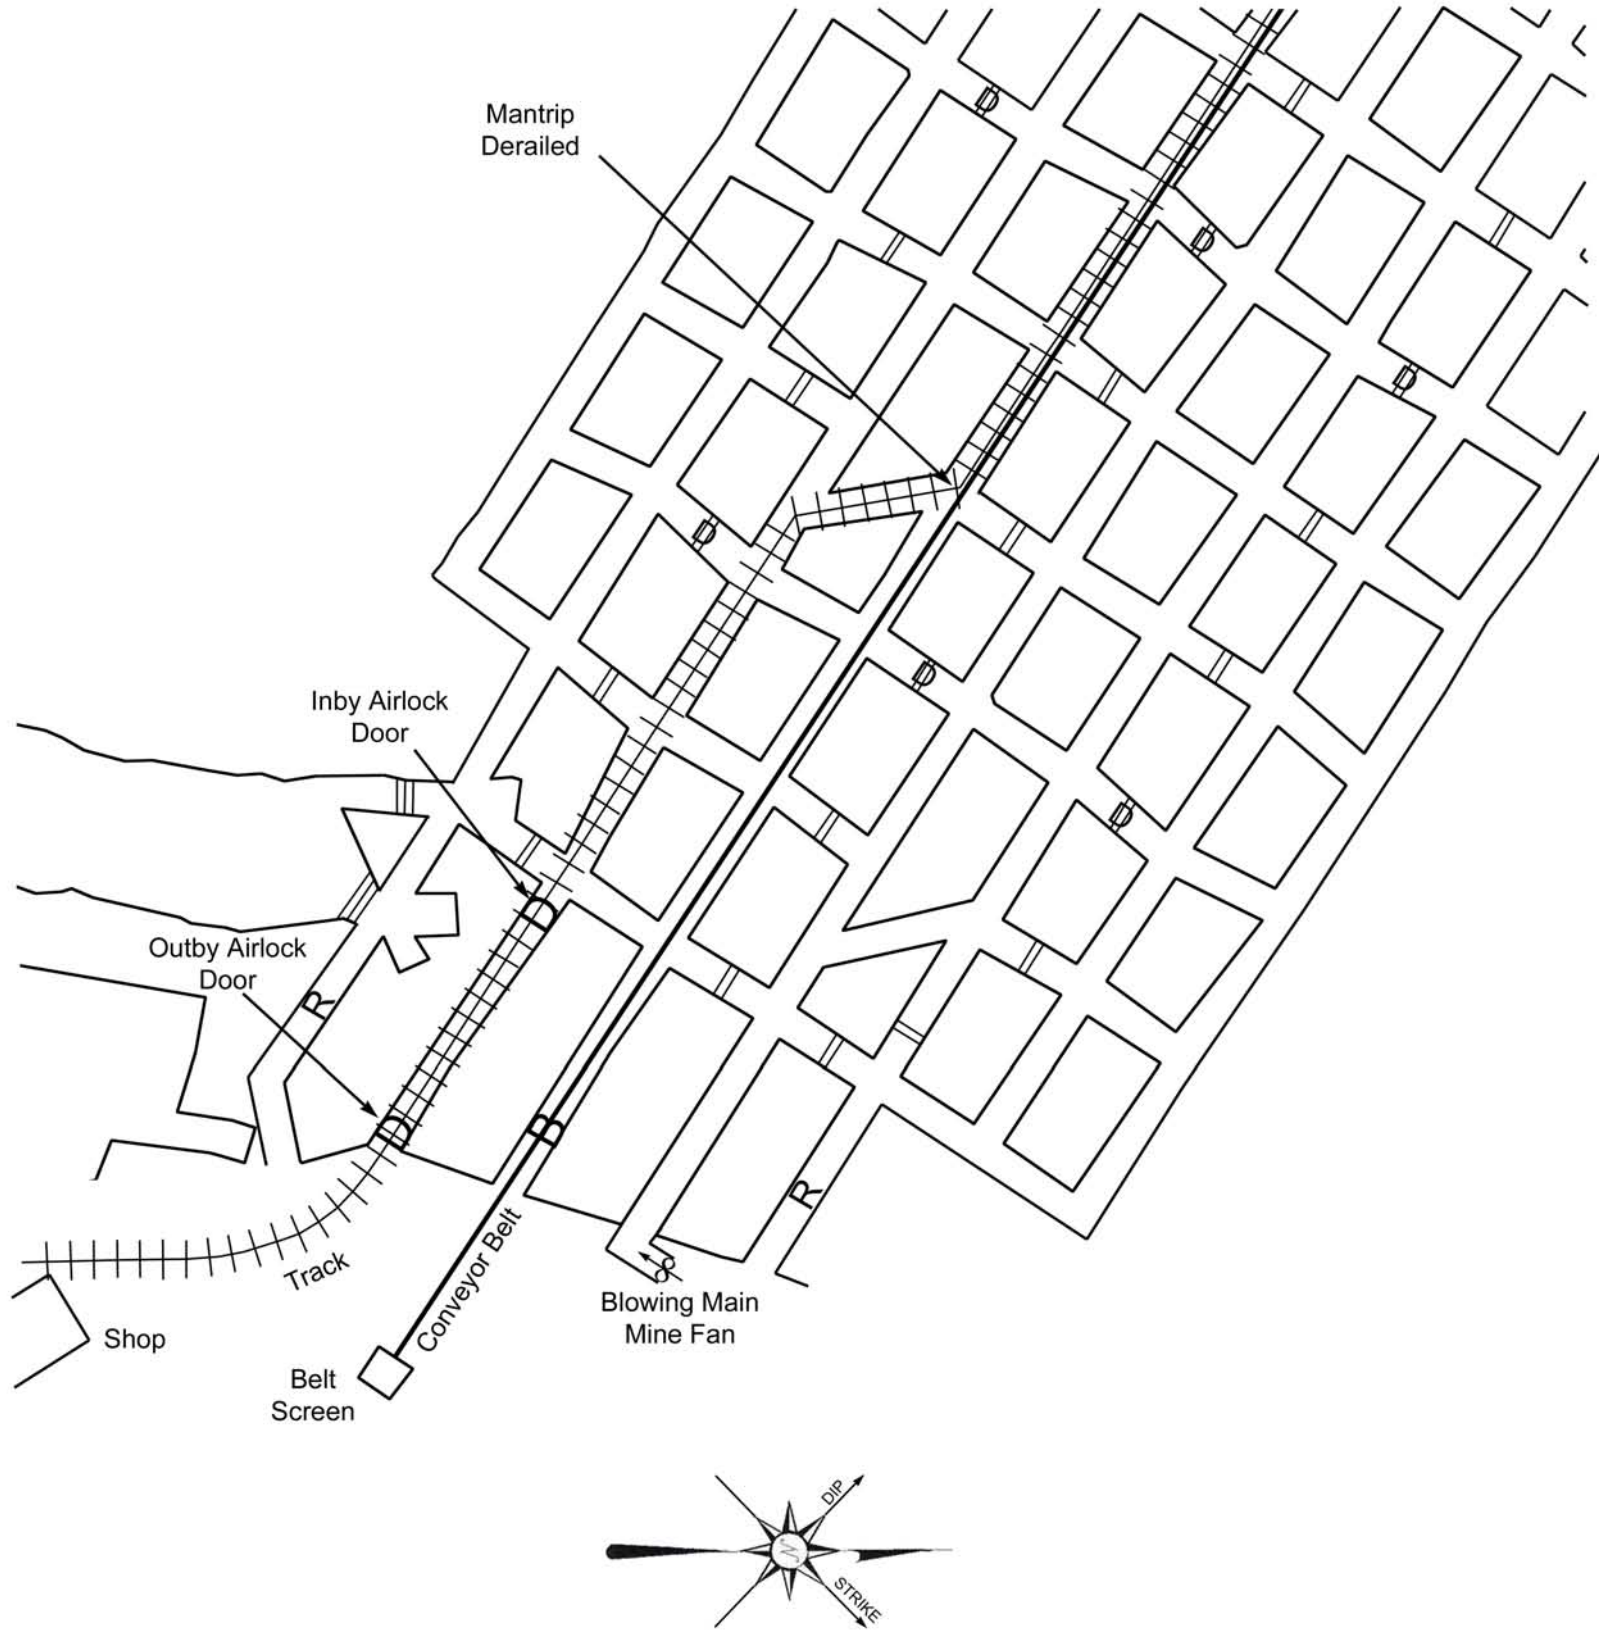
### Map of Accident Site

**AIRLOCK DOORS:** The airlock doors were used to control ventilation. The doors were constructed of 3/16-inch sheet metal with conveyor belt for sealing, hinged along a metal frame attached to the mine roof. The doors swung inby and upward, using an electric chain hoist and pulley arrangement. When the personnel carrier struck the door, the door swung up, hit the roof, bounced back and struck the victim.

The chain hoist was actuated to open and close the door with switches that were hung between the track and the rib on the operator's side of the track. Operators of personnel carriers, entering and exiting the mine, were required to stop and depress the switches until the chain hoist opened the door. The practice of stopping to open the outby door helped ensure that vehicles entered the mine slowly. Since the outby door was opened prior to the personnel carrier arriving at the portal, the vehicle was able to pass through the door at a higher than normal speed. The track grade at the inby door was 10.8 percent.

**TRACK CONDITIONS:** The grade from the surface to the accident site averaged 8.93 percent over a distance of approximately 170 feet. A maximum grade of 21.2 percent existed for a short distance in this area. The rails, mine roof, and ribs were damp to wet. The entry height averaged 110 inches near the surface and abruptly dropped to a height of approximately 47 inches outby the airlock door involved in the accident. The clearance above the rail to the edge of the airlock door in the open position was approximately 44 to 47 inches. The top of the personnel carrier was 28 inches above the rail. Clearance between the top of the vehicle and the mine roof in other areas of the mine is often less than 6 inches.

*Corrective Action:* The track was removed in this area and a continuous mining machine was used to reduce the grade from the portal to the inby airlock door location.

*Corrective Action:* The track portal canopy was extended 50 feet and both airlock doors were installed on the surface.
